# CASE STUDY

## Discharge & Chute Wear Rubber Ceramic Liners vs. Metal Liners

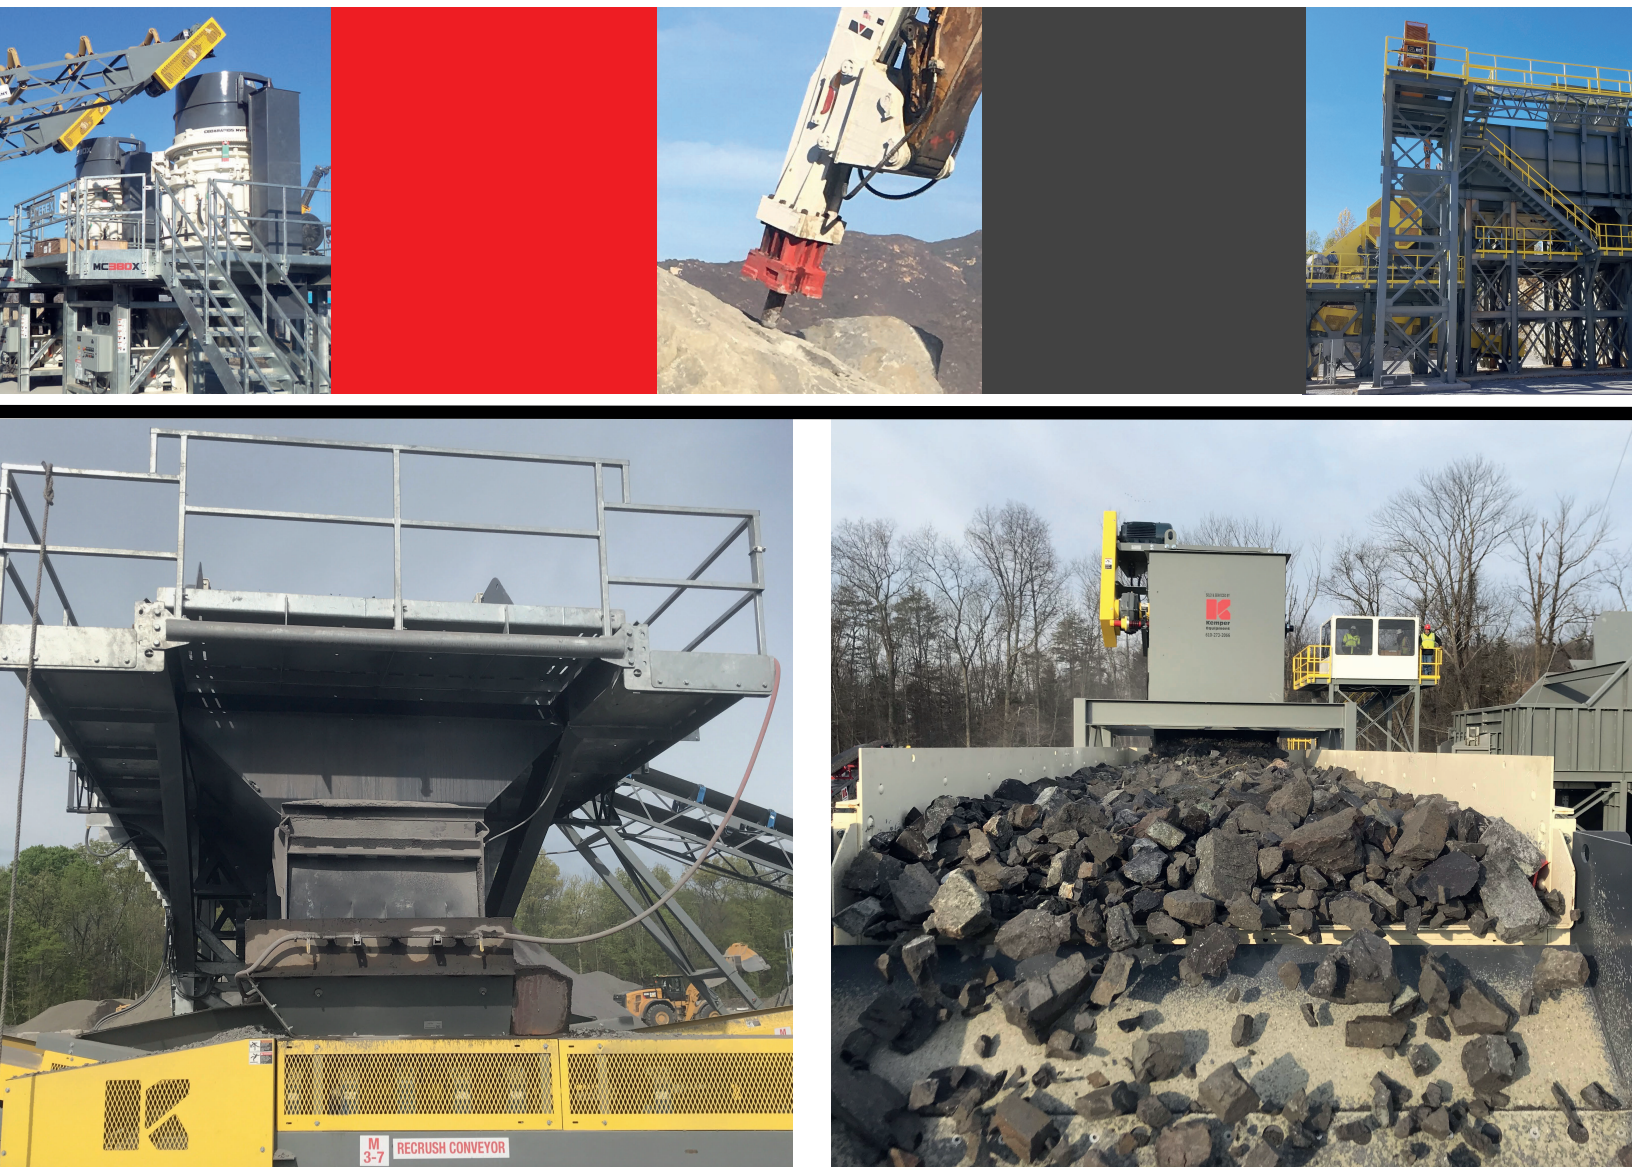
**SPECS:** Producer running a hard wearing mixture of Argillite and Diabase stone at 700TPH

**CHALLENGE:** The hard material caused extreme wear at all screen discharge chutes with existing metal liners. AR500 and Cresaba were lasting 2-4 weeks before needing to be changed.

**SOLUTION:** Kemper proposed and installed rubber ceramic liners from Valley Rubber. Still going strong after 11 months of wear, the new liners are good for another year! Our customer was so pleased with the decrease in downtime and confined space work, they have placed the rubber ceramic liner systems in each of their 3 screen discharge chute areas on site - this will translate into no chute maintenance for YEARS to come.
